**DEPARTMENT OF TRANSPORTATION**

Contract #: 04-0120F4Cty: SF/ALA Rte: 80 PM: 13.2/13.9File #: 1.28**WELDING INSPECTION REPORT****Resident Engineer:** Casey, William**Address:** 333 Burma Road**City:** Oakland, CA 94607**Report No:** WIR-028841**Date Inspected:** 05-Dec-2012**Project Name:** SAS Superstructure**OSM Arrival Time:** 700**Prime Contractor:** American Bridge/Fluor Enterprises, a JV**OSM Departure Time:** 1730**Contractor:** American Bridge/Fluor Enterprises, a JV**Location:** Job Site**CWI Name:** As noted below.**CWI Present:** Yes No**Inspected CWI report:** Yes No N/A**Rod Oven in Use:** Yes No N/A**Electrode to specification:** Yes No N/A**Weld Procedures Followed:** Yes No N/A**Qualified Welders:** Yes No N/A**Verified Joint Fit-up:** Yes No N/A**Approved Drawings:** Yes No N/A**Approved WPS:** Yes No N/A**Delayed / Cancelled:** Yes No N/A**Bridge No:** 34-0006**Component:** Tower**Summary of Items Observed:**

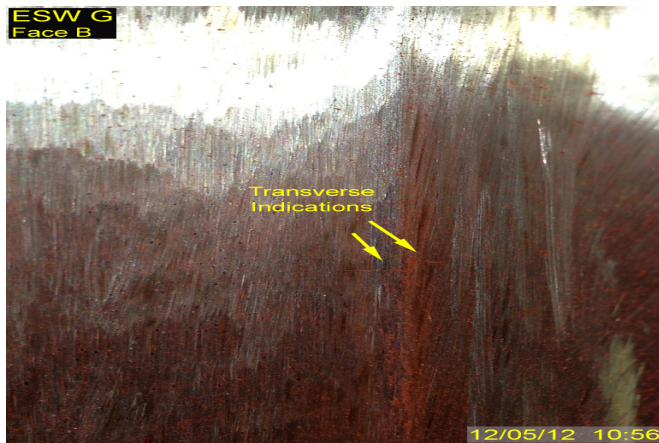
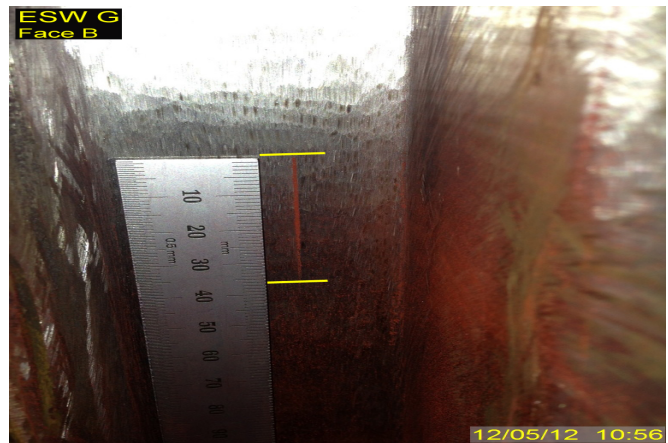
This QA performed observation of excavation of Electroslag Weld (ESW) designated as ESW G. Excavation was performed at location (Y= 7070mm~7400mm).

Excavation was performed by ABF welding personnel using a mechanical grinder removing approximately 1mm at a time. This QA observed Quality Control Inspector Andrew Keech performing visual inspection and Magnetic Particle Testing (MT) of this excavation between passes. This QA performed visual inspection and intermittent verification MT of this excavation between passes.
